Certificate of Conformance for Freight Container Mechanical Seal Testing
Seal Classification: High Security Seal

Test Report No. : M0829176-T01

Customer :		
	NovaVision, LLC 524 East Woodland Circle Bowling Green, Ohio 43402 USA	
Subject :	Freight containers Mechanical seals classification Testing	
Name of Article :	BOLT SEALS	
Type :		
	NovaVision, LLC	MS-B10
Received Date :	2023/08/29	
Test Dates :	2023/09/12~2023/09/26	
Date Issued :	2023/09/26

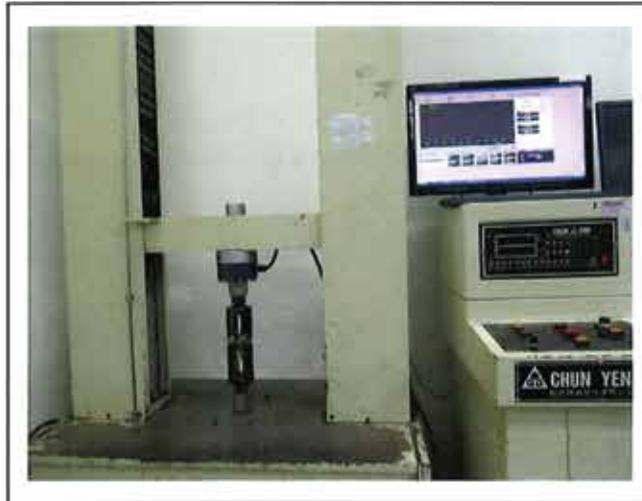
Testing Instrument : Universal Testing Machine (No.TG0103)

The seal was gripped in a tensile machine and a pull force applied.

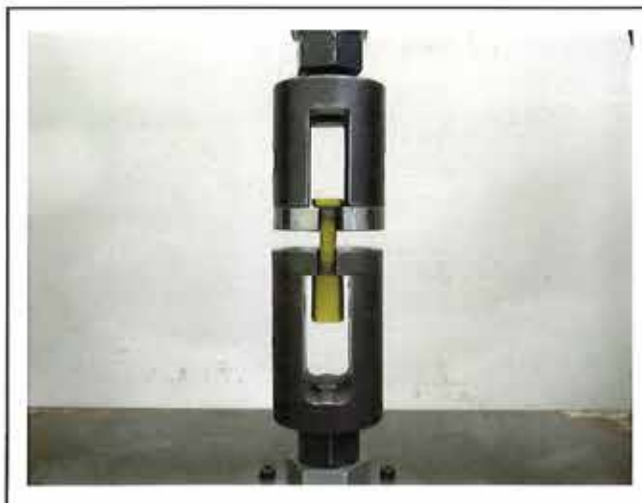
Tensile Set up

Specimen No.	Requirement Load to failure	Result kN	Seal classification
01	10.0 kN : High security seal 2.27 kN : Security seal < 2.27 kN : Indicative seal	19.0	High security seal (H)
02		21.7	High security seal (H)
03		18.6	High security seal (H)
04		19.3	High security seal (H)
05		19.1	High security seal (H)

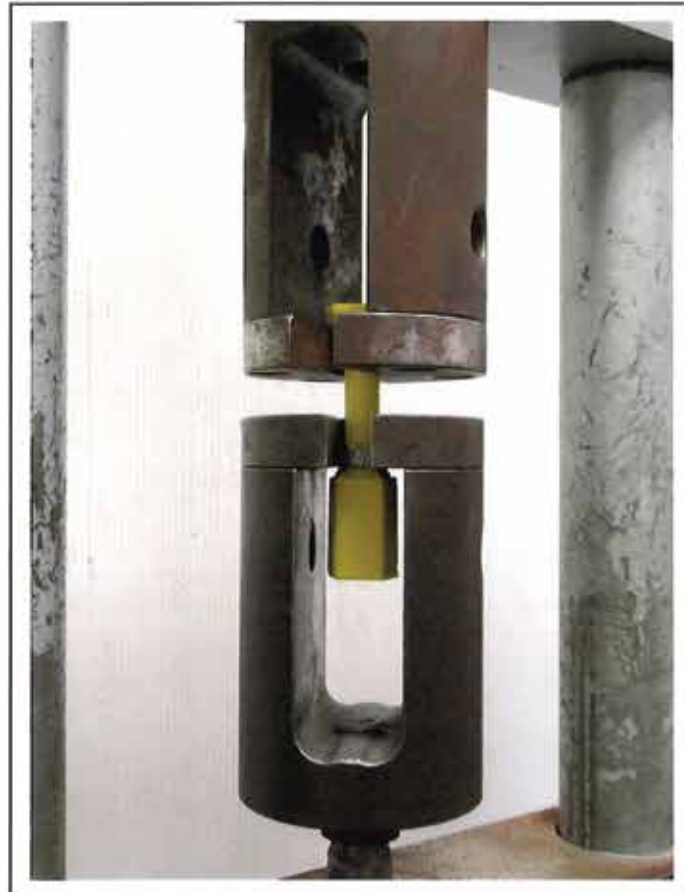
Impact Set up

The impact test is performed at 18 degrees C and minus 27 degrees C of temperature.

The impact load is applied at the locking mechanism of the seal in the direction

opposite the direction used in locking the seal.

Impact Test at 18±3°C					
Specimen No.	Requirement	Result Joule			Seal classification
		13.56	27.12	40.68	
16	40.68J : High security seal 27.12J : Security seal <27.12J : Indicative seal 5 impacts at each load	Pass	Pass	Pass	High security seal (H)
17		Pass	Pass	Pass	High security seal (H)
18		Pass	Pass	Pass	High security seal (H)
19		Pass	Pass	Pass	High security seal (H)
20		Pass	Pass	Pass	High security seal (H)

Impact Test at -27±3°C					
Specimen No.	Requirement	Result Joule			Seal classification
		13.56	27.12	40.68	
21	40.68J : High security seal 27.12J : Security seal <27.12J : Indicative seal 5 impacts at each load	Pass	Pass	Pass	High security seal (H)
22		Pass	Pass	Pass	High security seal (H)
23		Pass	Pass	Pass	High security seal (H)
24		Pass	Pass	Pass	High security seal (H)
25		Pass	Pass	Pass	High security seal (H)
