試驗報告 TEST REPORT

Test Report No. : O0526161-T01

Customer :	ZHEJIANG OUFU CONTAINER SEAL CO., LTD. Building 25, NO.1336 HANGFU ROAD, CHONGFU TOWN, TONGXIANG CITY, JIAXING CITY, ZHEJIANG PROVINCE, CHINA 314511	
	NovaVision, LLC 524 EAST WOODLAND CIRCLE BOWLING GREEN, OH 43402 USA	
Name of Article :	BOLT SEALS	
Type :	Zhejiang Oufu	OF-BS06
	NovaVision, LLC	MS-B7
Serial No. : 01~ 26		
Quantity Tested : 26		
Inspection Reference : ISO 17712:2013(E)

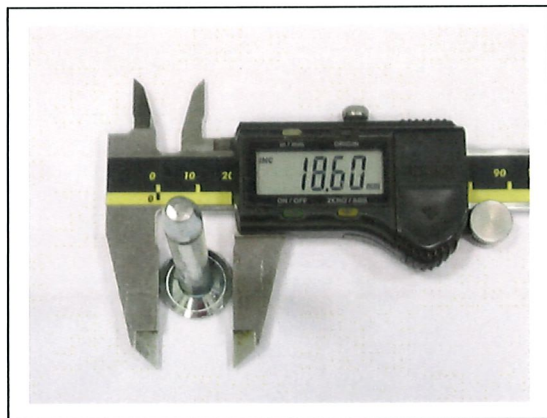
Specimen No.	Measurement (mm)		Pass/Fail
26	Pin Head	18.60	Pass
	Lock Body	18.09	Pass

The minimum diameter (or minimum widest cross-dimension) for the metal components of a bolt seal shall be 18 mm.

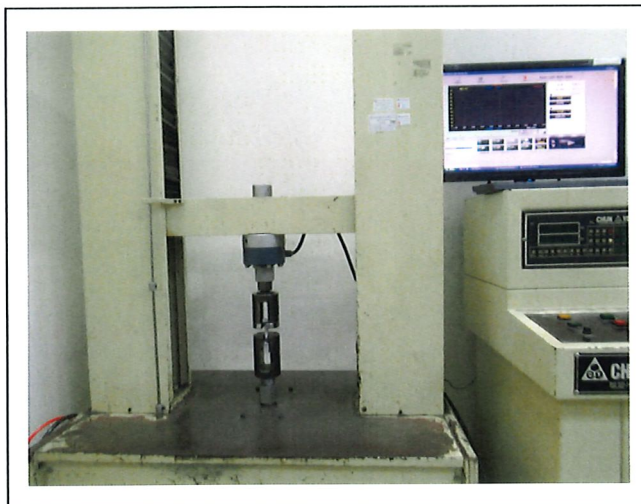
Testing Instrument : Universal Testing Machine (No.TG0103)

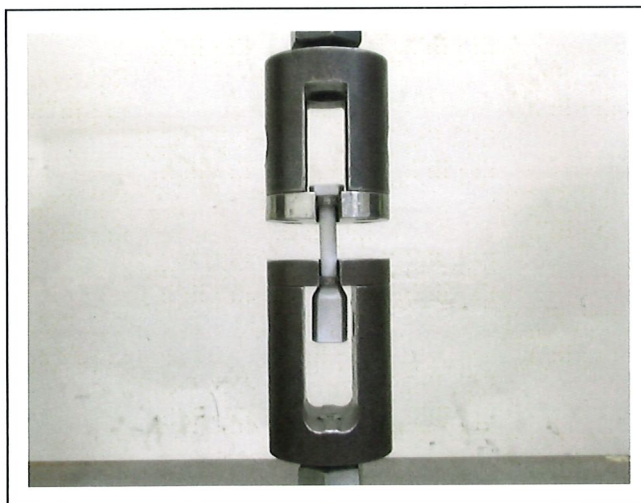
Tensile Set up

The seal was gripped in a tensile machine and a pull force applied.

Specimen No.	Requirement Load to failure	Result kN	Seal classification
01	10.0 kN : High security seal 2.27 kN : Security seal < 2.27 kN : Indicative seal	13.1	High security seal (H)
02		14.0	High security seal (H)
03		13.7	High security seal (H)
04		14.0	High security seal (H)
05		13.5	High security seal (H)

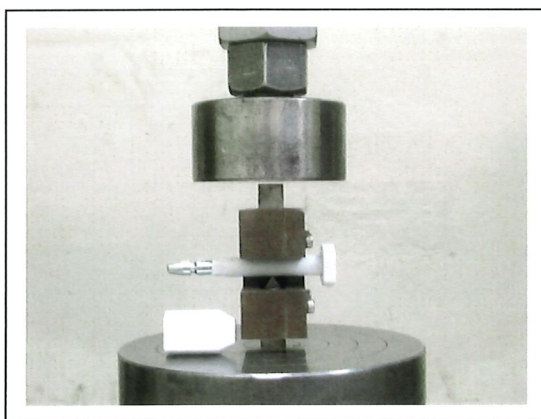
Shear Set up

The seal was fixed in a universal testing machine to withstand cutting with shearing blades and a compressive load applied slowly until the seal is severed.

Specimen No.	Requirement Load to failure	Result kN	Seal classification
06	3.336 kN : High security seal 2.224 kN : Security seal <2.224 kN : Indicative seal	8.896	High security seal (H)
07		8.896	High security seal (H)
08		8.896	High security seal (H)
09		8.896	High security seal (H)
10		8.896	High security seal (H)

**SAFETY PRECAUTIONS** - Do not exceed a shear force greater than 8900N(2001lbf). If the specimen has not failed at that force, halt the test and unload the test equipment. Record a shear force of 8896N (2000 lbf). Sudden and violent rupture of the test specimen can endanger personnel, equipment and property.

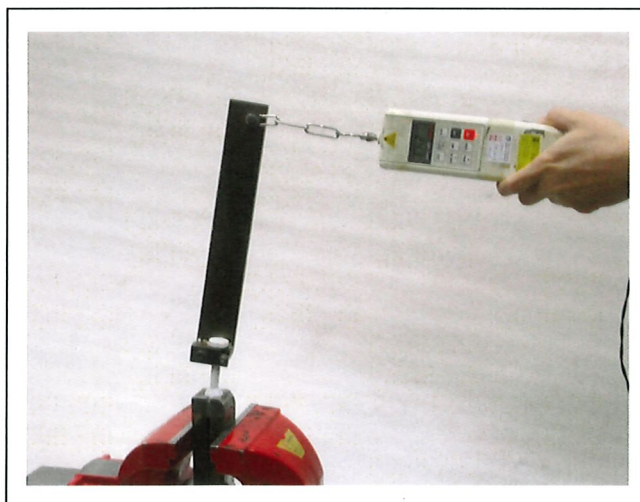
Bend Set up

Fix the locking end on the universal testing machine in a horizontal position.

Apply a load on the remaining portion of the seal at a distance (the moment arm) above the fixed end so as to bend the seal 90 degrees.

Specimen No.	Requirement Bending moment to failure	Result N·m	Seal classification
11	50 N·m : High security seal 22 N·m : Security seal < 22 N·m : Indicative seal	56.4	High security seal (H)
12		54.5	High security seal (H)
13		54.7	High security seal (H)
14		55.8	High security seal (H)
15		52.8	High security seal (H)

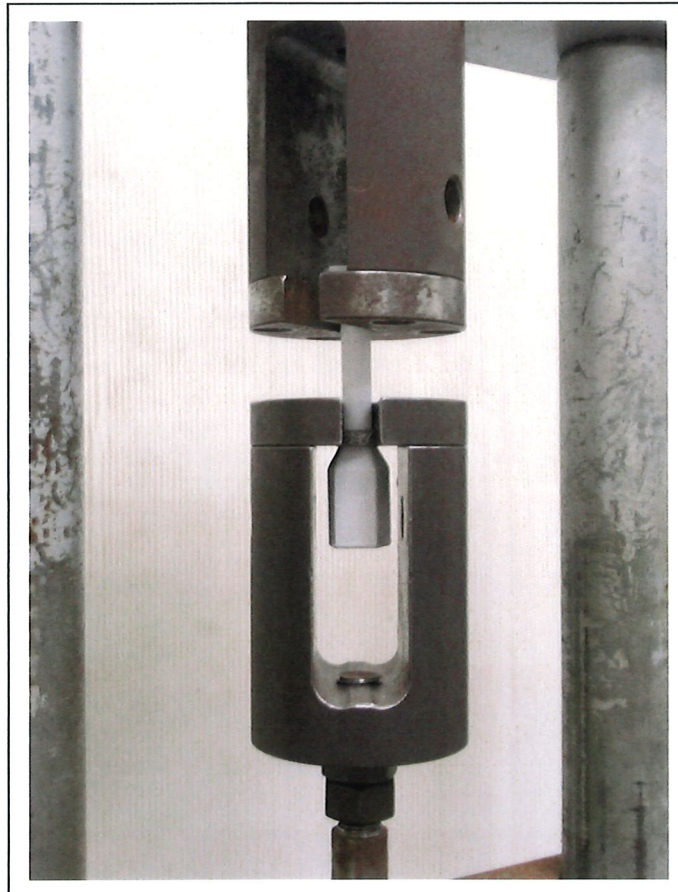
Impact Set up

The impact test is performed at 18 degrees Celsius and minus 27 degrees Celsius of temperature.

The impact load is applied at the locking mechanism of the seal in the direction opposite the direction used in locking the seal.

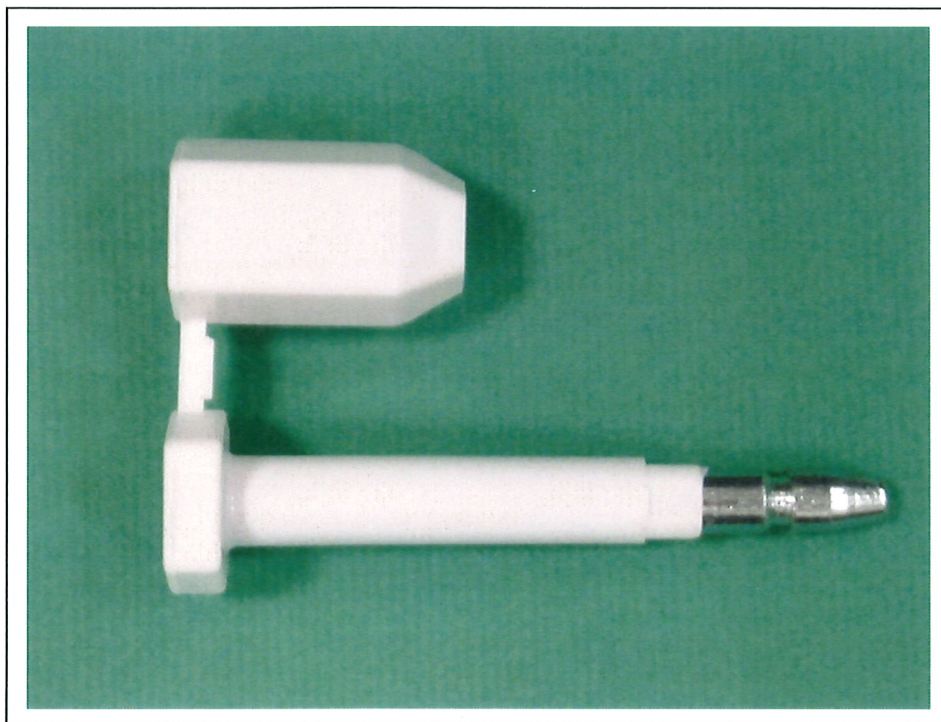
Name of Article : BOLT SEALS

Type	Zhejiang Oufu	OF-BS06
	NovaVision, LLC	MS-B7
