試驗報告 TEST REPORT

TEST REPORT NO. : O0526163-T01

Customer :	ZHEJIANG OUFU CONTAINER SEAL CO., LTD. Building 25, NO.1336 HANGFU ROAD, CHONGFU TOWN, TONGXIANG CITY, JIAXING CITY, ZHEJIANG PROVINCE, CHINA 314511	
	NovaVision, LLC 524 EAST WOODLAND CIRCLE BOWLING GREEN, OH 43402 USA	
Name of Article :	CABLE SEALS	
Type :	Zhejiang Oufu	OF-CS3.5
	NovaVision, LLC	MS-CS3.5
Serial No. :	01~25	
Quantity Tested :	25	
Specification No. :	ISO 17712:2013(E)

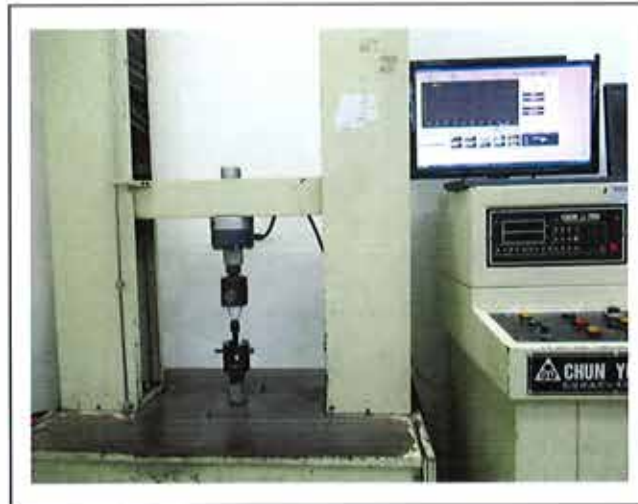
The seal was gripped in a tensile machine and a pull force applied.

Tensile Set up

Specimen No.	Requirement Load to failure	Result kN	Seal classification
01	10.0 kN : High security seal 2.27 kN : Security seal < 2.27 kN : Indicative seal	11.9	High security seal (H)
02		11.6	High security seal (H)
03		11.5	High security seal (H)
04		11.7	High security seal (H)
05		12.0	High security seal (H)

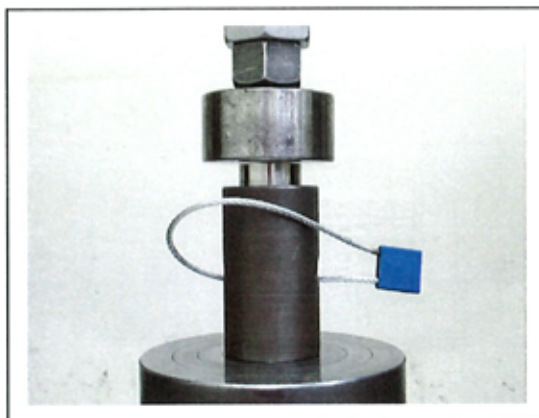
The seal was fixed in a universal testing machine to withstand cutting with shearing blades and a compressive load applied slowly until the seal is severed.

Shear Set up

Specimen No.	Requirement Load to failure	Result kN	Seal classification
06	3.336 kN : High security seal 2.224 kN : Security seal <2.224 kN : Indicative seal	6.800	High security seal (H)
07		7.097	High security seal (H)
08		7.479	High security seal (H)
09		7.276	High security seal (H)
10		6.898	High security seal (H)

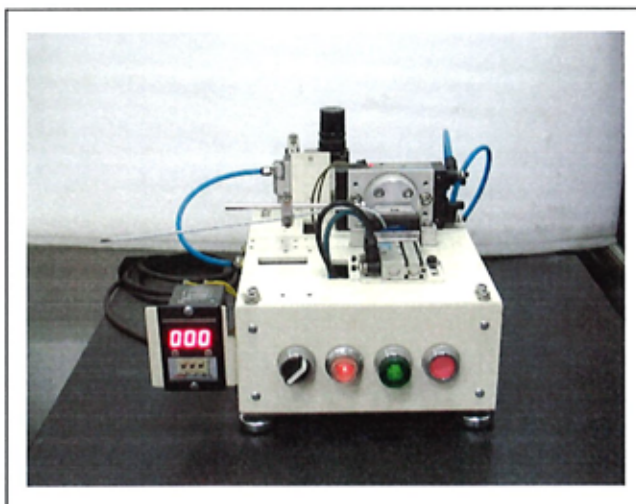
Fix the locking end and flex the material adjacent to this fixed end repeatedly through an arc of 180° until failure

Bend Set up

Specimen No.	Requirement Cycles to failure	Result Cycles	Seal classification
11	501 : High security seal 251 : Security seal <251 : Indicative seal	> 501	High security seal (H)
12		> 501	High security seal (H)
13		> 501	High security seal (H)
14		> 501	High security seal (H)
15		> 501	High security seal (H)

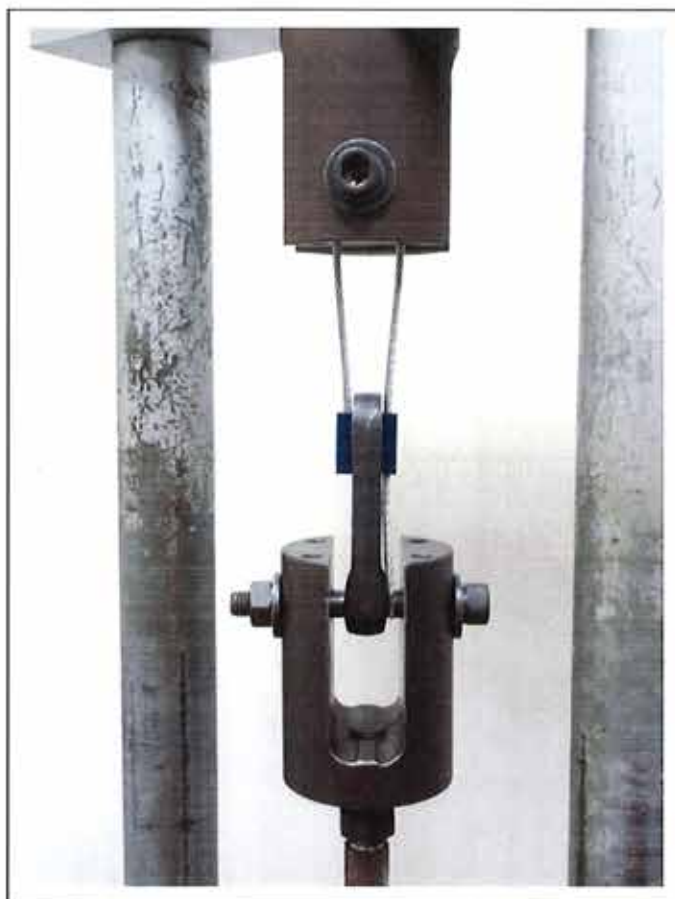
The impact test is performed at 18 degrees Celsius and minus 27 degrees Celsius of temperature.  
The impact load is applied at the locking mechanism of the seal in the direction opposite the direction used in locking the seal.

Impact Set up

Impact Test at 18±3°C					
Specimen No.	Requirement	Result Joule			Seal classification
		13.56	27.12	40.68	
16	40.68J : High security seal 27.12J : Security seal <27.12J : Indicative seal <b>5 impacts at each load</b>	Pass	Pass	Pass	High security seal (H)
17		Pass	Pass	Pass	High security seal (H)
18		Pass	Pass	Pass	High security seal (H)
19		Pass	Pass	Pass	High security seal (H)
20		Pass	Pass	Pass	High security seal (H)

Impact Test at -27±3°C					
Specimen No.	Requirement	Result Joule			Seal classification
		13.56	27.12	40.68	
21	40.68J : High security seal 27.12J : Security seal <27.12J : Indicative seal <b>5 impacts at each load</b>	Pass	Pass	Pass	High security seal (H)
22		Pass	Pass	Pass	High security seal (H)
23		Pass	Pass	Pass	High security seal (H)
24		Pass	Pass	Pass	High security seal (H)
25		Pass	Pass	Pass	High security seal (H)

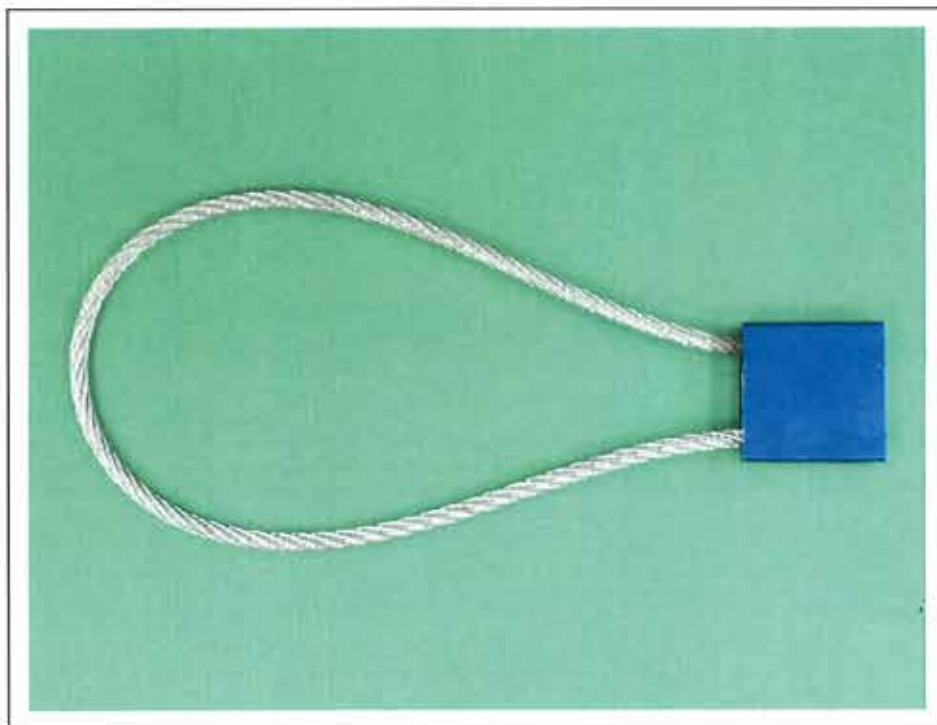
Name of Article : CABLE SEALS

Type	Zhejiang Oufu	OF-CS3.5
	NovaVision, LLC	MS-CS3.5
